Technical Report No. 2

**AN ARCHAEOLOGICAL CURATION-NEEDS ASSESSMENT
FOR
FORT BLISS, TEXAS**

**U.S. Army Corps of Engineers
St. Louis District,
Mandatory Center of Expertise for the
Curation and Management of Archaeological Collections,
Archaeological Curation-Needs Assessments
Technical Report No. 2**

1996

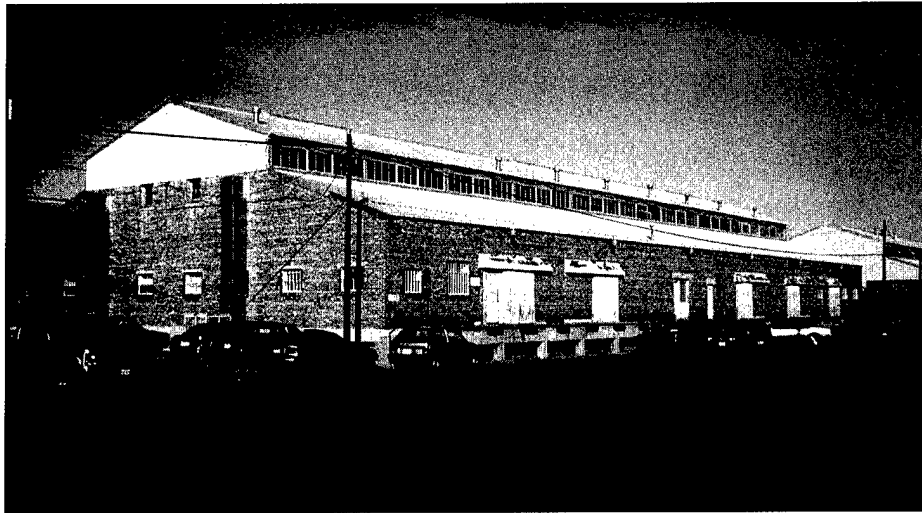
Figure 1. Exterior view of Building 1105.

This single-story building is 16,000 ft² (Figure 1). Of this, the environmental division occupies approximately 4,000 ft². The collections storage area in Building 1105 is approximately 304 ft² in size. A long-term collection storage area, laboratory, offices, library, and restrooms are included in the 4,000 ft² environmental division.

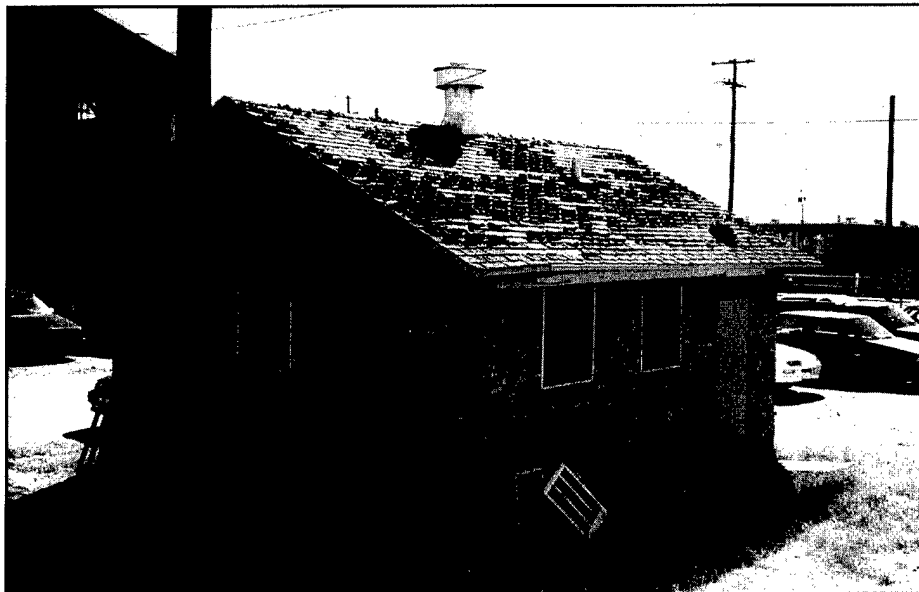
Located east across the street from Building 1105, this 144-ft², single-story building (Figure 2) serves as the repository for groundstone material. Only one-half of this building is used for archaeological storage; the other half is occupied by biological equipment and supplies.

Figure 2. Exterior view of Building 1127. Note deteriorating roof.

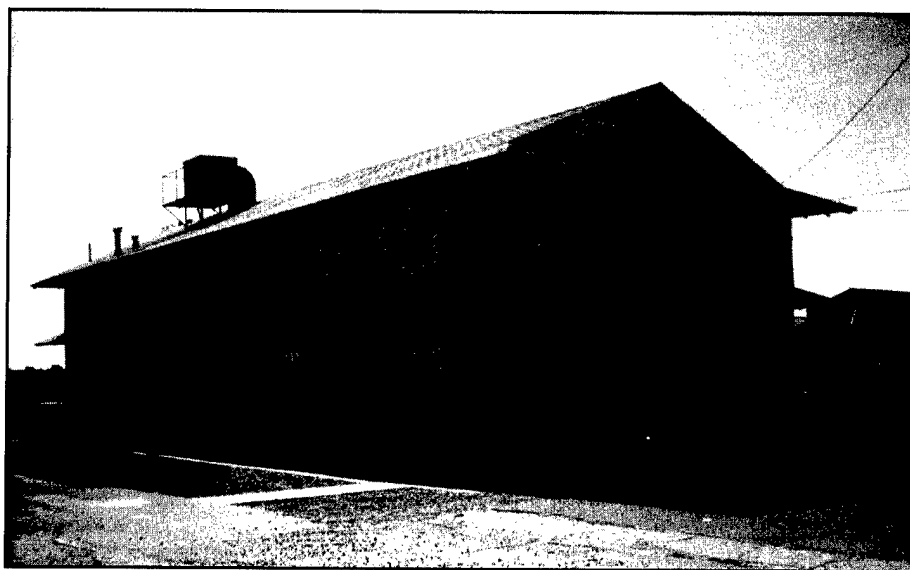
This two-story building (Figure 3), located northeast of Repositories 1 and 2, encompasses 1,110 ft². It contains various laboratories (including archaeology, geology, and soils), offices, and restrooms. An estimated 125 ft³ of material is currently undergoing analysis in this repository. Although this building is actively used, it has been condemned and poses a significant safety risk to all personnel.

Figure 3. Exterior view of Building 1160. This structure is condemned, and the load on structure floors from artifacts poses a safety hazard.

1. As Building 1160 has been condemned, is structurally stressed from current archaeological artifact load, has no fire protection, and only has a 15-minute burn rating, it is recommended that all activities in this building immediately be moved. The safety of all personnel is currently compromised, and any supervisor who continues to let his/her staff work there is putting their safety at risk.
2. If collections are to remain in Building 1127, upgrade the fire detection/suppression system. Minimally, install smoke alarms, fire extinguishers, and sprinkler systems.
3. If the groundstone collection is to remain in Building 1127, replace the damaged shingles on the roof, and install a dead-bolt lock on the door.
4. Install an electronic motion detector in the collections storage area of Building 1105 as an additional security precaution.

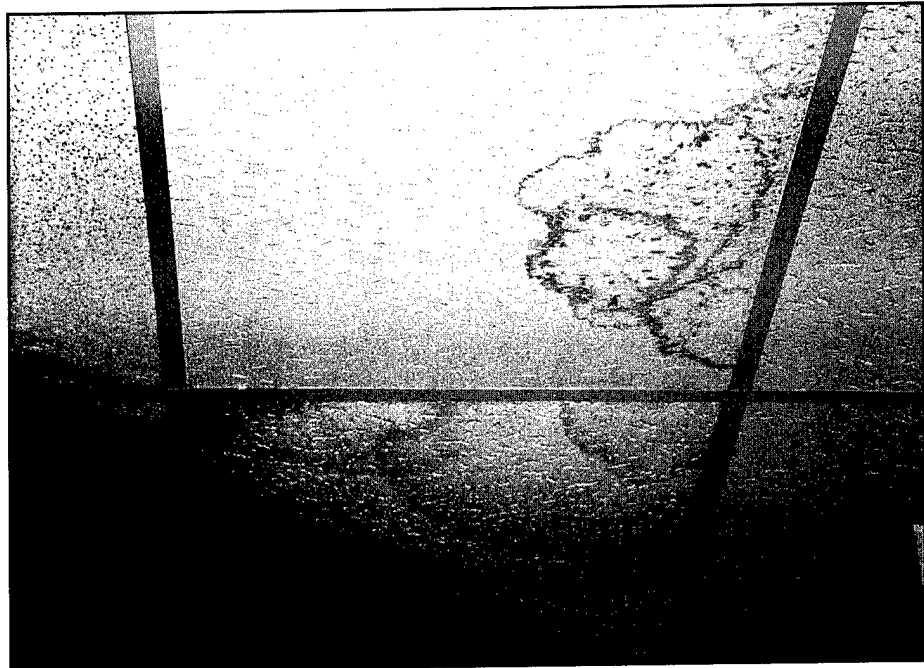
There are five windows on the south side of the building, seven on the east side, eight on the west side, and a skylight running the entire length of the building. There are no windows in the collections storage area. Six double-batten sliding doors on the front (south) side of the building have been sealed and are no longer used. There are two wood panel doors on the exterior of the portion of the building used by the environmental division, one single, wood panel door on the south side, and one double, wood panel on the north wall. The interior door to the collections storage area consists of a single, wood panel door. The floor is poured concrete covered by carpeting and tile, and there is a suspended acoustical-tile ceiling. Several of the ceiling tiles exhibit signs of water damage (Figure 4).

Figure 4. Water-damaged ceiling tiles in Building 1105.

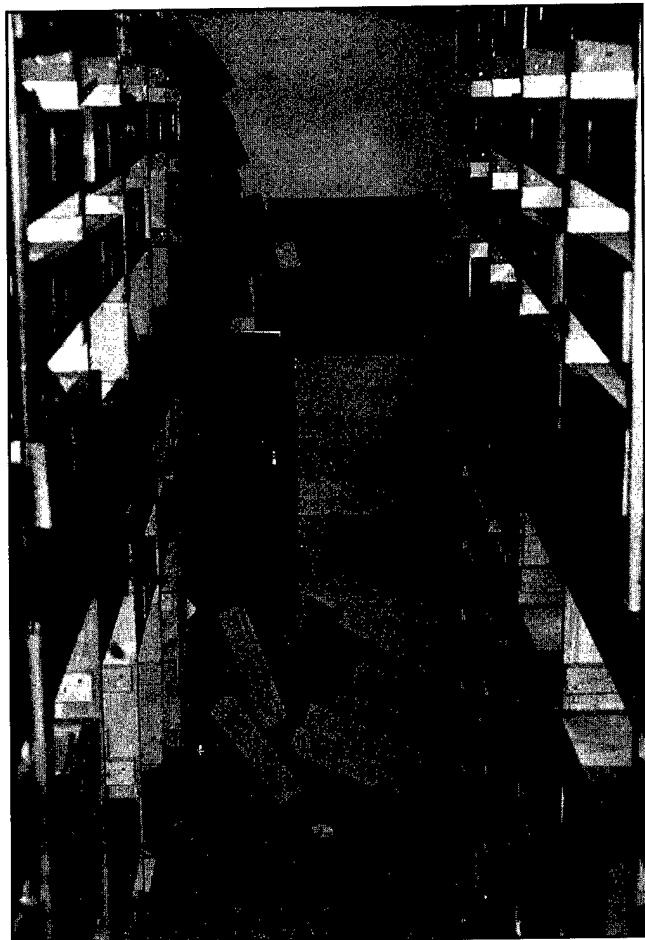
The plumbing and electrical systems have been upgraded at some point in the past. The collections storage area is filled to approximately 50% capacity, and it is estimated that it will be over 100% capacity after the reprocessing of the current collections is finished. The aisles of the collections storage room are cluttered with empty cardboard flats, empty wood drawers, and supplies (Figures 5 and 6).

Figure 5. Cluttered aisles of collections storage room in Building 1105. Access to the collections is impeded by clutter, and the fire hazard is substantial.

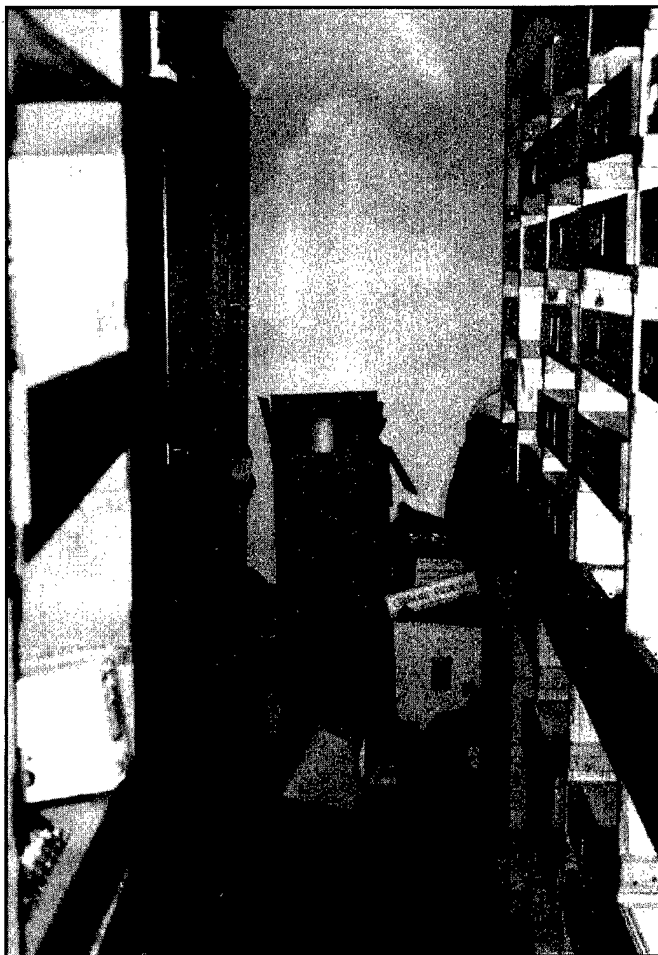
Figure 6. Cluttered aisles of collections storage room, Building 1105, pose major fire hazards.

Three fire extinguishers, all located in the laboratory adjacent to the collections storage area, and a sprinkler system constitute the fire suppression system in this building. It was impossible to tell when the fire extinguishers had last been charged as they had no tags. The aisles of the collections storage area are cluttered with empty drawers, cardboard flats, and supplies, all comprising a fire hazard.

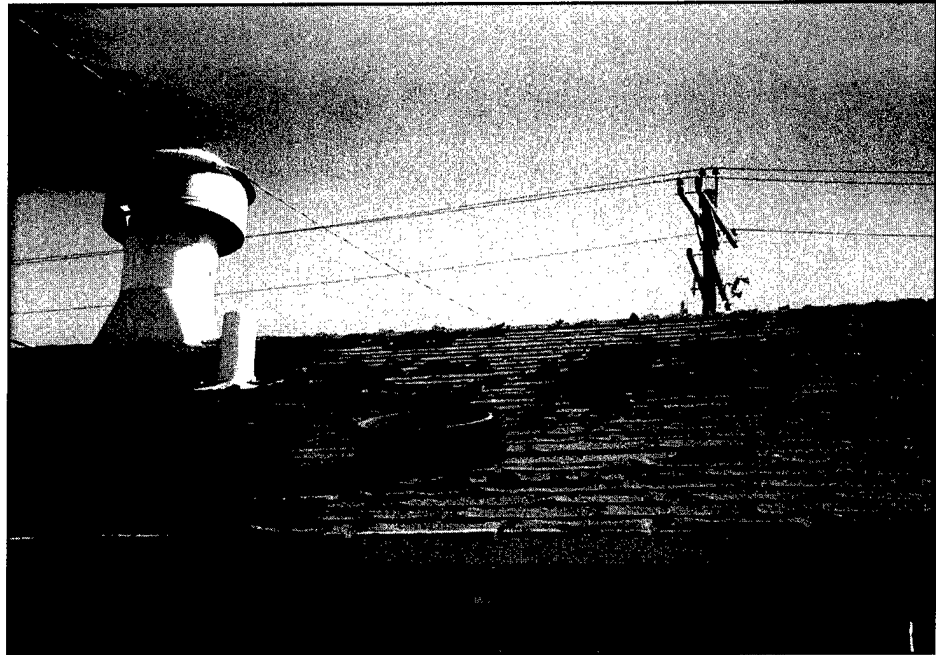
This single-story World War II-era building was originally used as a pump house. The roof is covered with asphalt shingles, many of which need replacing (Figure 7). The ceiling is constructed of wood two by fours. The foundation is poured concrete, and both the exterior and the interior walls are faced with brick. There are seven windows in this facility, all measuring 41.5 in long and 36 in wide. There is one window on the north wall, two on the south wall, two on the east wall, and two on the west wall. Windows have wood frames and are covered with metal mesh on the outside. There is one single, wood panel door on the west side of the building.

Figure 7. Damaged shingles on roof of Building 1127.

1. The shingles on Building 1127 are severely damaged.
2. Buildings 1127 and 1160 have no fire detection/suppression systems.
3. All but three of the drawers (secondary containers) in Building 1105 are overpacked and difficult to access.
4. Only Buildings 1105 and 1160 have any type of temperature controls, but none of the facilities have any way to monitor or control humidity.
5. There is no integrated pest management system in place for any of the facilities. Certain types of insects are known to damage paper records beyond repair, destroying important information. Additionally, rodents and snakes are known to nest in packing material, eventually disturbing and possibly destroying artifacts.
6. The computer records are the only type of documentation that have a security back-up copy; however, the copies are not catalogued.

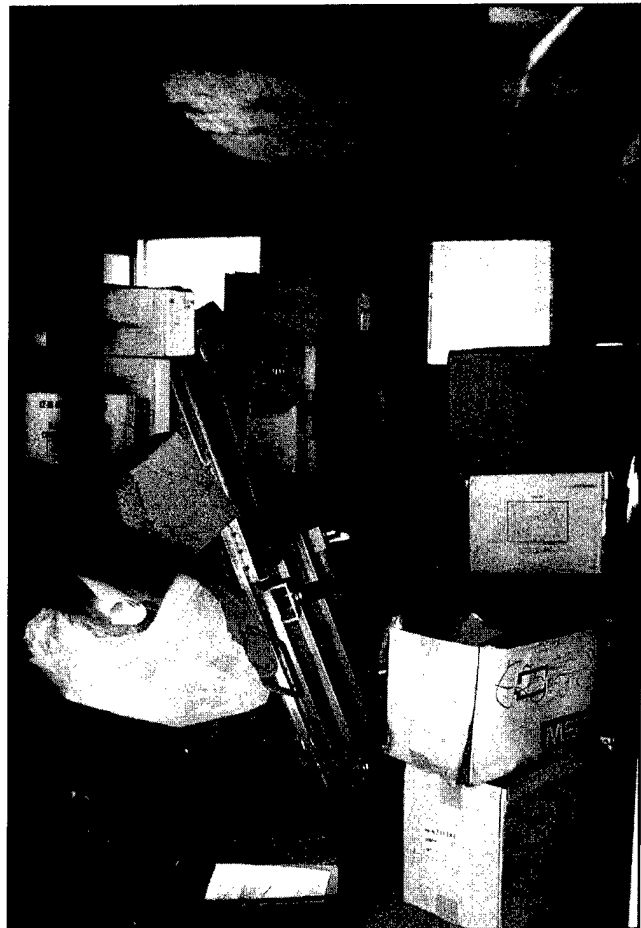
Only one-half of the 144 ft² is devoted to the storage of archaeological collections; the remaining half is dedicated to the haphazard storage of supplies and equipment used by the biologists. The groundstone storage area is currently filled to approximately 30% capacity (Figure 8); however, because of the technique of storing groundstone items in wood drawers, as well as the weight of the material, it is doubtful that much more archaeological material will satisfactorily fit into this storage facility.

Figure 8. Clutter in groundstone storage, Building 1127, poses a major fire hazard. Note sagging storage support in ceiling.

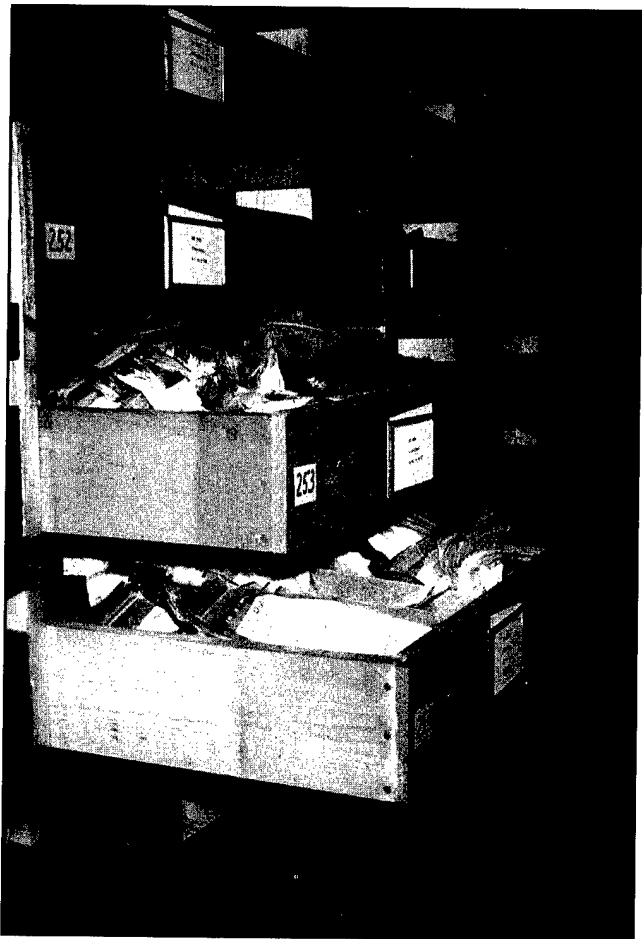
All of the artifacts in Building 1105 are curated in 0.75 ft³ unsealed, unlined wood drawers constructed of nails and glue. Drawers contain acidic paper labels with typed information pertaining to Fort Bliss site numbers and a series of artifact catalog numbers. Many of the primary containers include dividers constructed of acidic cardboard beer flats. All but three of these drawers are overpacked and difficult to access (Figure 10).

Figure 10. View of storage units and primary and secondary containers in Building 1105. Artifacts are improperly stored and overpacking of drawers tears artifact bags and hinders access to the collections.

5. All but three drawers in Building 1105 are over-packed. It is not only difficult to tell which sites are filed in these drawers, but also awkward to remove and replace secondary containers within the drawers. Repack all drawers and collections so that they are easier to manage and collections are easier to access. In their present condition the collections cannot be used or properly managed.
